Reliability Engineering and Resilience

Earth Dam Behavior under Earthquake Movements- An Overview

Vahed Ghiasi^{1*}

In this review article, we examine the behavior of earthen dams under earthquake movements. Earthen dams perform satisfactorily when exposed to strong earthquakes. Their performance is usually related to the nature of the soil used for the structure. Most well-constructed earthen dams can significantly vibrate the earthquake without damaging effects. Dams made of compacted clay materials on clay foundations or bedrock withstood strong ground movement. Compared to older embankments built on sandy materials or of sand or silt with inefficient density and tailings dams, all of them showed almost some instances of failure, which was initially due to the liquefaction capability of these materials. They are considered a type of hydraulic structure in this period, and tailings dams are the most dangerous types of earth dams. The more accurate and durable equipment and tools are used during the construction and operation of the dam, the minor deformation is created in the dam, and the more controllable it becomes. Utilizing up-to-date knowledge and benefiting from the cons

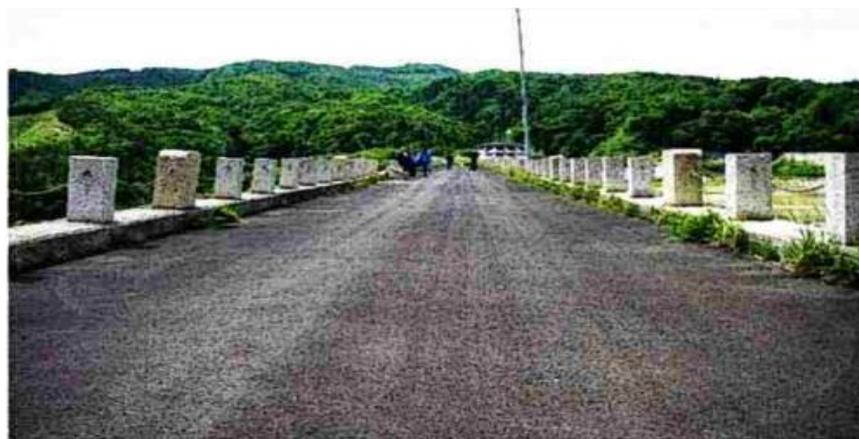
The clay core settled along the dam axis up to 400 mm, and the rock crust up to a maximum of 200 mm. According to Tanny et al., As can be seen in Figure 2, the gravel shell and core placement have caused a general inward rotation in the direction of the midline of the dam. According to Figure 3, some of the columns have failed irregularly and without a definite rule. 200 mm steps in the series remain constant [35]

Fig. 2. Showing the crown of the Eratozawa Dam and the failures and deviations of historical monuments [19].

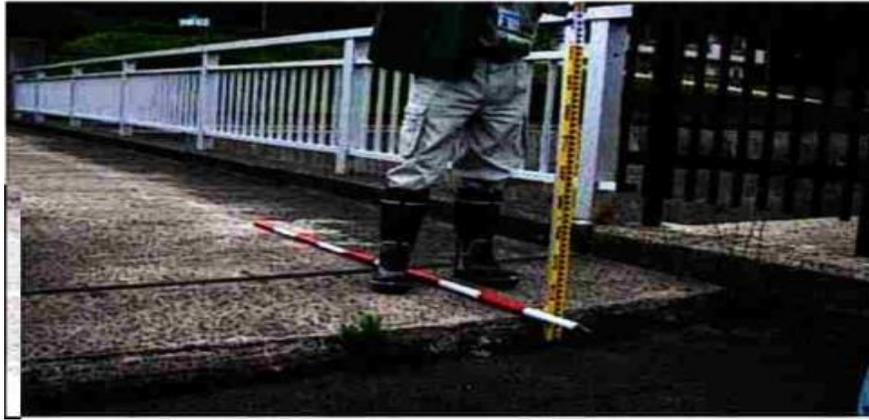
Fig. 3. 10 cm embankment in the overflow of the Eratozawa Dam [35].

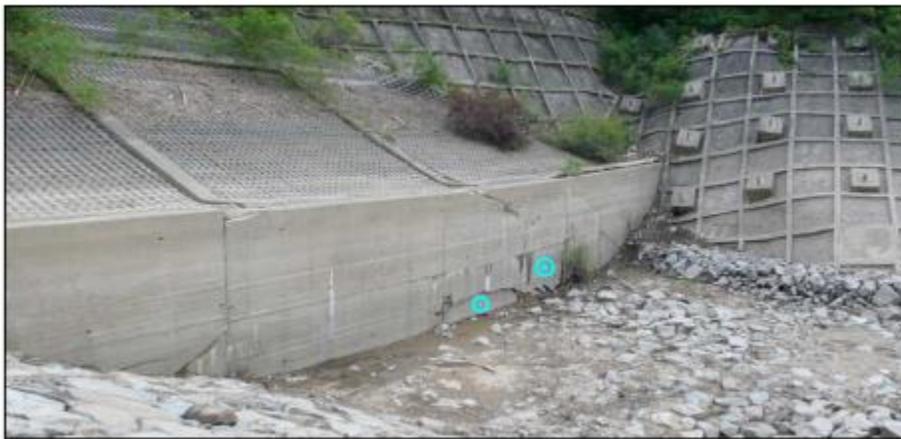
Partial cracks in the retaining wall as part of the overflow are shown in Figure 5. This crack is the result of earthquakes. According to a 2008 report by Kayen et al. [18].

Fig. 5. Cracks in the retaining wall of the Eratozawa Dam [18].

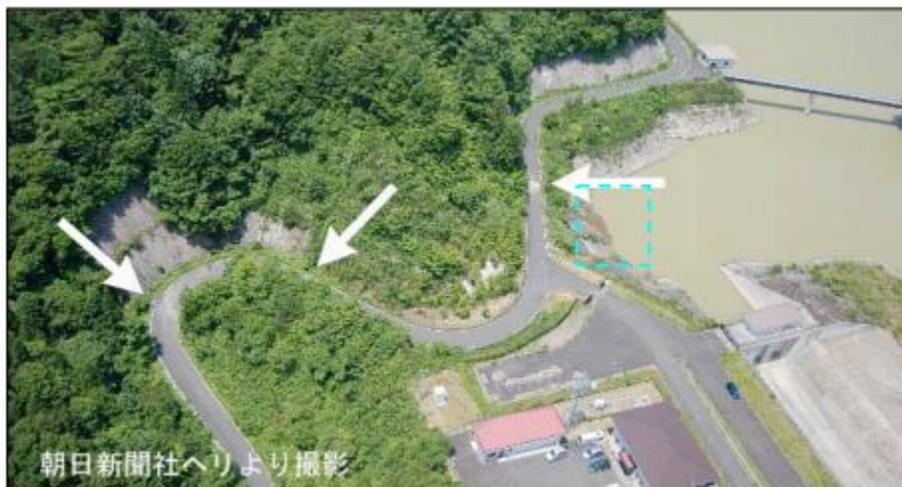
Figure 6 shows the damaged areas of the road in the direction of the cracks, and these cracks only show the damage to the structural members [18].

Fig. 6. The aerial photo shows three areas of cracking on the road. Overflow wall cracking shown in Figure 5 occurred below the right arrow [18].

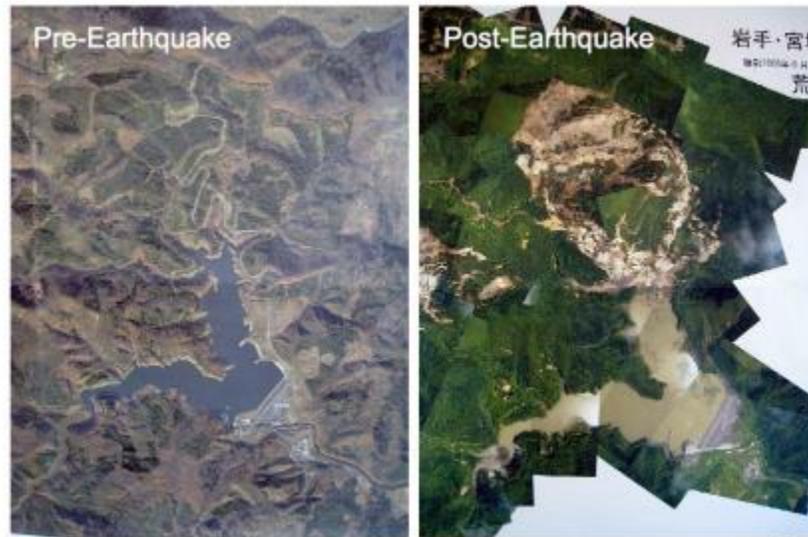
The total volume of the massive landslide is estimated at 50 million cubic meters, of which about 1.5 million cubic meters are in the reservoir (see Figure 7). The landslide was about 1.3 km long and 0.8 km wide. However, the slope was very gentle, about 3 to 4 degrees, and the soil mass shifted by 200 to 500 meters. During the earthquake, the lake's height increased by 2.4 m due to landslides and some tectonic deformations (from 26875 to 270/9). In 2008, Kayen et al. [18] Stated that 3.5 km of the dam access road had been closed by an earthquake.

Fig. 7. Landslide inside the Eratozawa Dam reservoir [18].

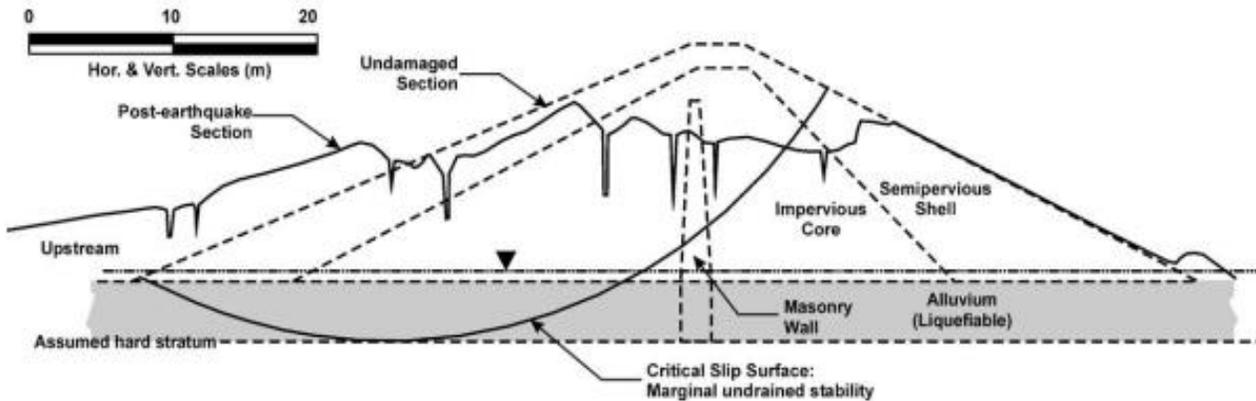
Fig. 9. Cross-section of Chang Dam, which shows the damaged and undamaged embankment. [39].

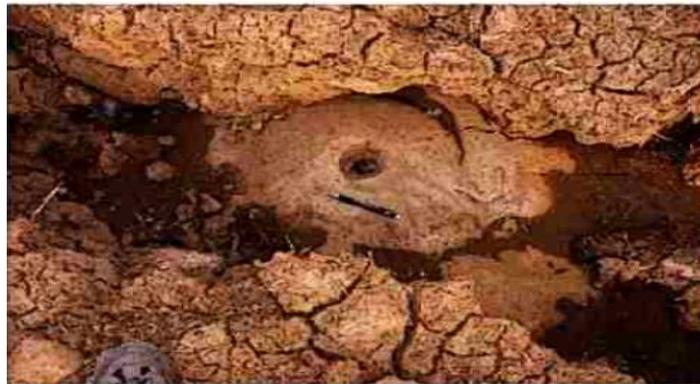
Fig. 11. Sand boiling was observed in the Chang Dam reservoir near the dam claw [40].

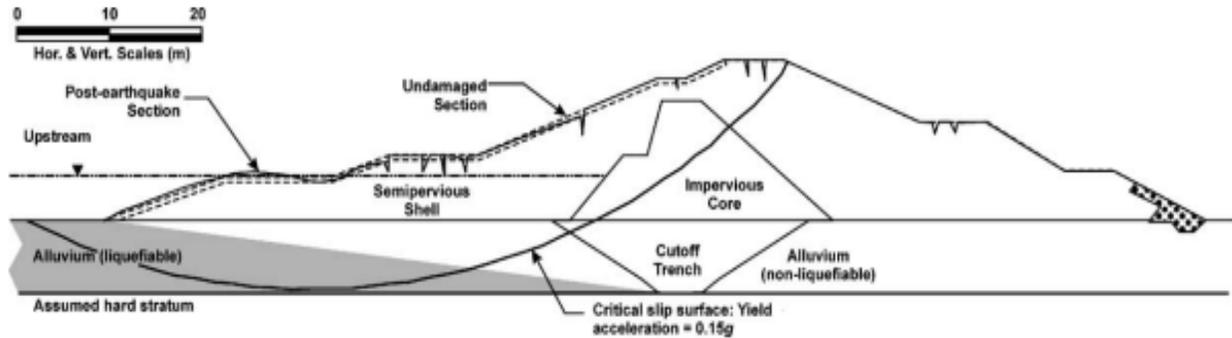
Fig. 12. The transverse section of Tapar Dam indicates the damaged embankment and has not been damaged [39].

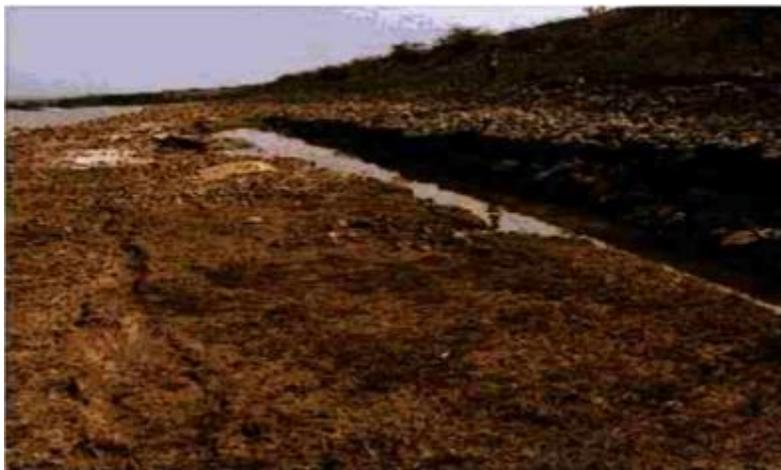
Fig. 13. Lateral drift near the claw of the Tapar Dam [40].

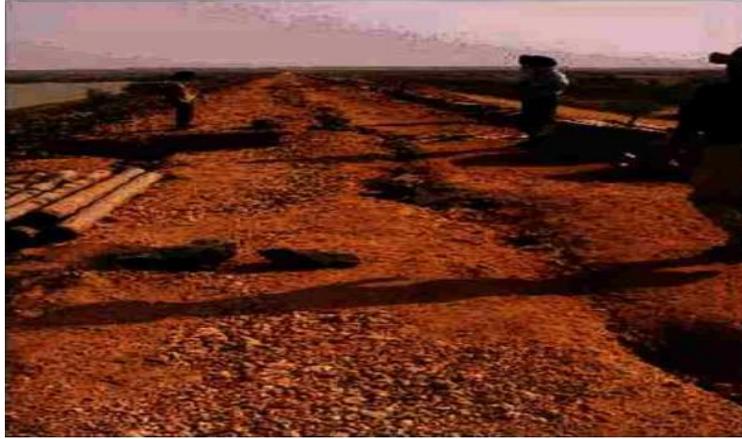
Fig. 14. Longitudinal cracks along with the crown of the Tapar Dam to a depth of 3 m [37].

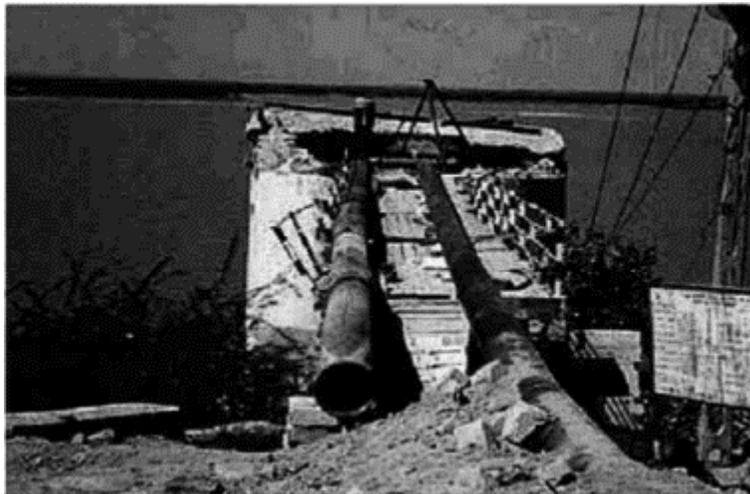
Fig. 15. Damage to the Tapar Dam [37].

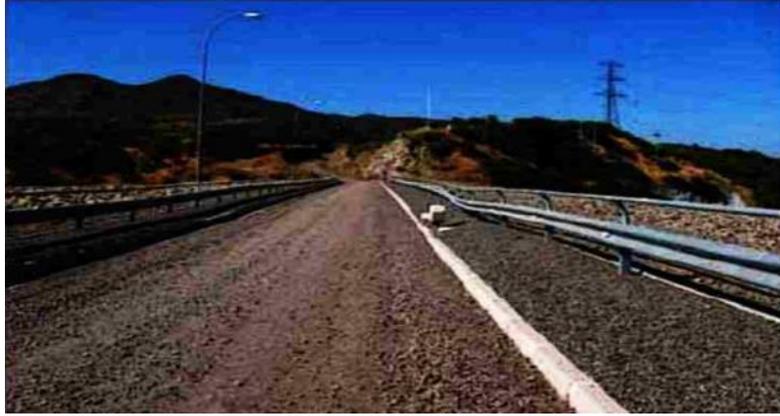
The dam and the overflow outlet structure functioned well during and after the earthquake. There were no signs of major problems or equipment inefficiencies. Partial longitudinal cracks were observed in the crown at the highest point of Khakirir. The maximum sitting was 279 mm. Seismic analysis of this leak predicted 230 mm. A significant depression in the crown is shown in Figure 22, approximately where the sealing trench was located [22].

Fig. 22. Depression in the crown along the sealing trench of the Konontobujo Dam [22].
