Reliability Engineering and Resilience

Failure Analysis of a Partially-Collapsed Building Using Analytical Hierarchical Process

For technical emphasis, a case study of a partially-collapsed one-story building in Ikwuano Local Government Area of Abia State, Nigeria to thoroughly examine the cause of the building collapse using multi-decision making technique known as analytical hierarchical process (AHP); the material properties were examined, the building skeletal elements were assessed and to obtain the engineering behavior and classification of the soil. AHP is a multi-criteria decision-making tool essentially suitable for the evaluation of complex and multi-attribute decisions involving the correlation of decision elements which are not easy to quantify. It consist of formation of a ranking of decision elements. The AHP enables the decision maker to work out the major sections and subsections of a given problem into a hierarchical structure (family tree) that is based on expert's judgments by pairwise comparisons. Then to the pairs of homogenous criteria, experts' interviews and pairwise comparison judgments are applied to obtain the general priorities which is utilized for th

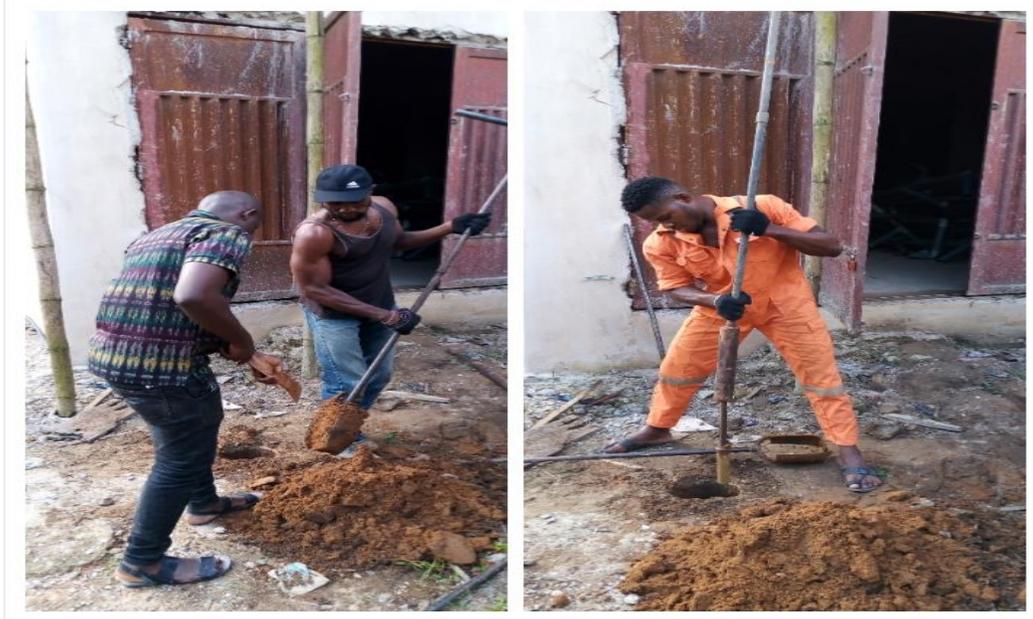
Fig. 1. Collection of Soil Sample with Hand Auger.

The investigation program include boring of two (2) Hand Auger holes of 150mm diameter to the depths of 4m and five points of Non Destructive test of concrete. The hand auger boring was carried out with the possibility of continuous sampling at each lithological change of the strata while the Nondestructive test was done with Schmidt Rebound Hammer by sounding. The determination depth of the foundation and the inspection of the soil's properties at that depth considering the building dead and live load was also carried out as part of the assessment of the building's foundation.

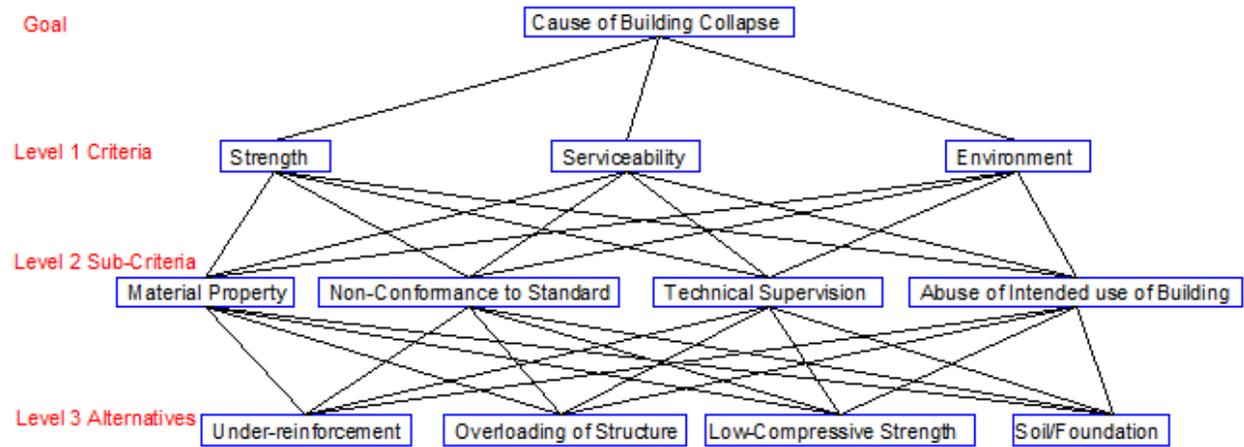
Fig. 2. Hierarchy of the Problem Decision Factors.

After the technical assessments and physical observation of the soil and skeletal framework of the collapsed building, weights are then assigned to the criteria, sub-criteria and alternatives in the hierarchical structure shown in the figure 2. The problem's goal is the general objective which mainly influences the problem decision. It should be directly related to the challenge at hand. The goal have to be singular i.e. the decision maker should avoid a case of satisfying multiple goals for one problem. The alternatives of the problem are the varying options which is being weighed in decision-making while the criteria are the factors used in the evaluation of alternatives with respect to an already defined goal. The alternatives would be picked depending on the criteria which is used to define how well they meet the problems goal [24].

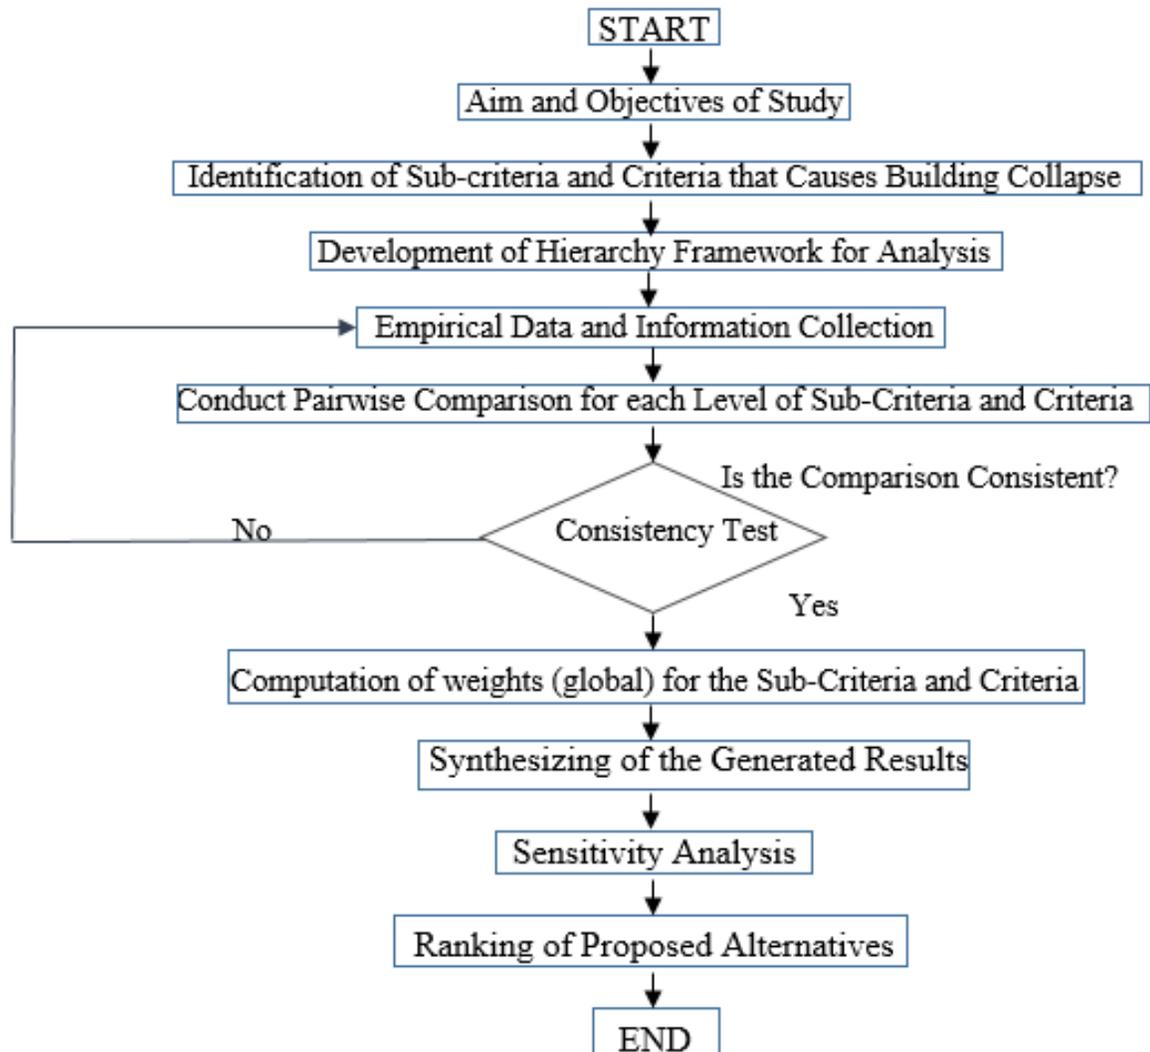
Fig. 3. AHP process flowchart.

The flowchart of this research study showing the required steps and the sequence of programs followed in this research study as presented in fig. 3.

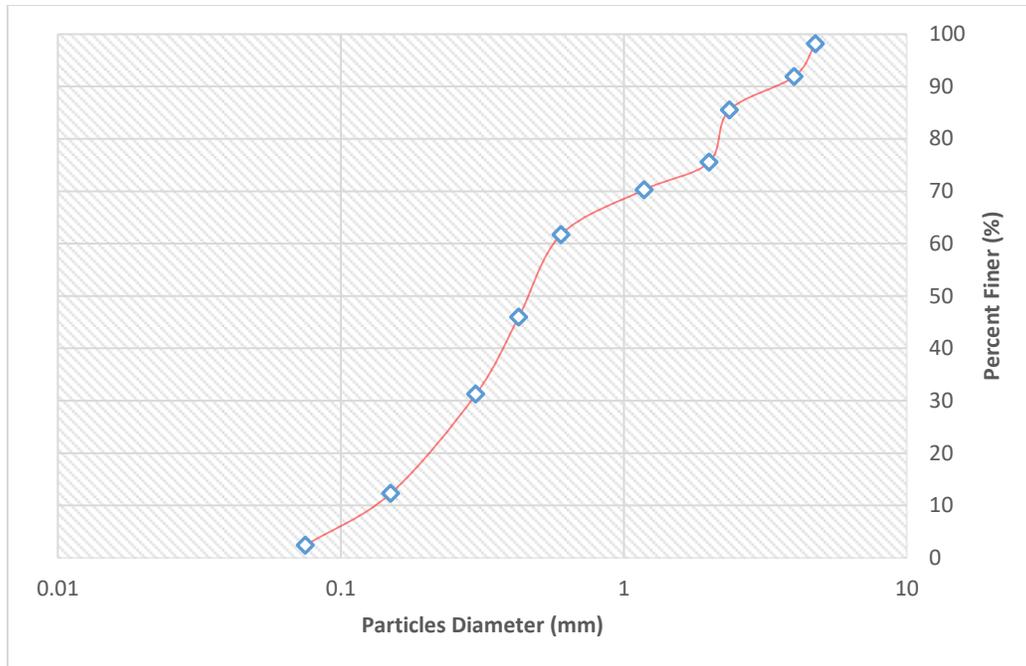
Fig. 4. Particle Size Distribution of Soil.

The particle size distribution analysis shows the range of particle sizes present in the soil as presented in fig. 4. The soil is well graded and contains silty (non-plastic) or clayey gravel and sand. The strength properties also showed the values are of acceptable standards for materials to be used as foundation materials.

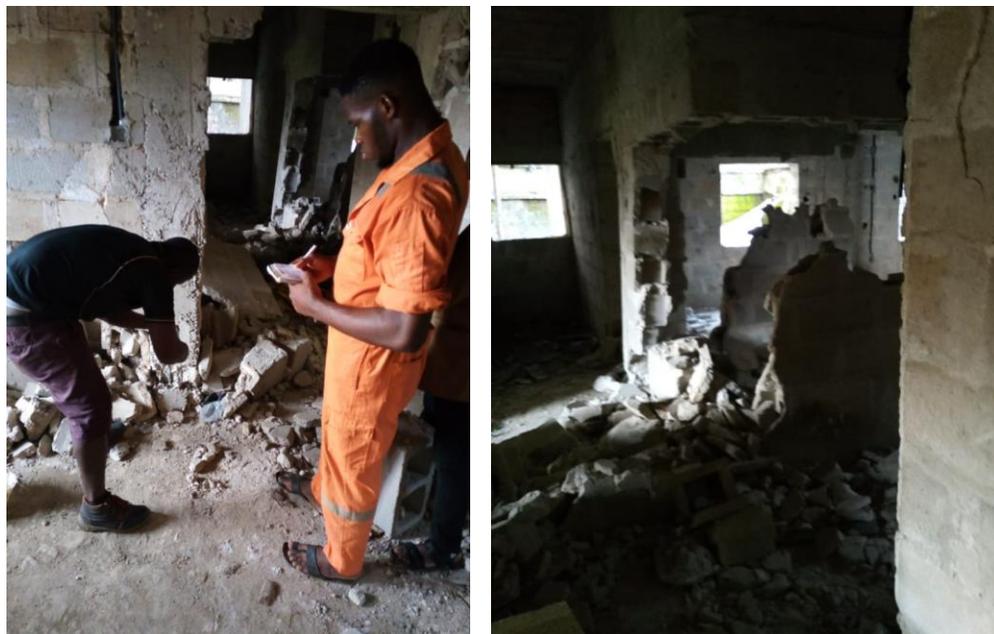
Fig. 5. Cracks at Partition-walls of the Case Study Building.

From field inspection of the building it was observed that the sub-structure and super-structure walls had cracked in several regions of the building. The building's general arrangement of the skeletal frame-work and as a result, insufficient columns allowed the slab and connecting beams to span more than 6 m with inadequate depth; the cracks are more pronounced in the side walls, the columns and beams. Fig. 5 shows a partially-collapsed portion of the partition-walls of the building under study.

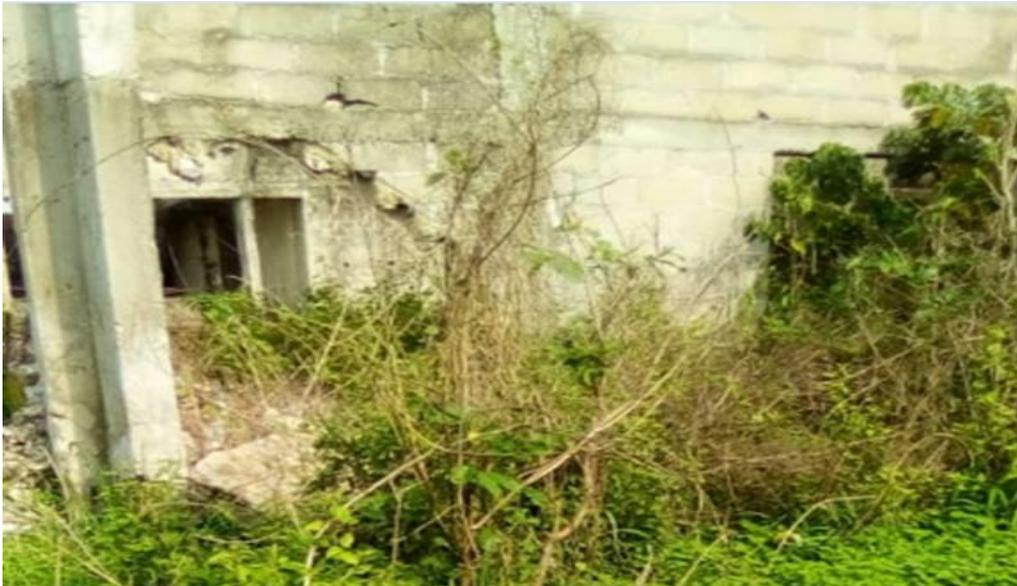
Fig. 6. Cracks drawing from the foundation of the building.

The long vertical cracks extend to the superstructure walls from the foundation as shown in the fig. 6. The cause of this cracks emanating from the lower region to the upper region of the building is;

- The substructure block walls and mortar were too weak withstand the lateral load due to the steepness of the land and applied load.
- Failure to introduce expansion joints at critical sections where the steepness of the land induces lateral pressure to the substructure.

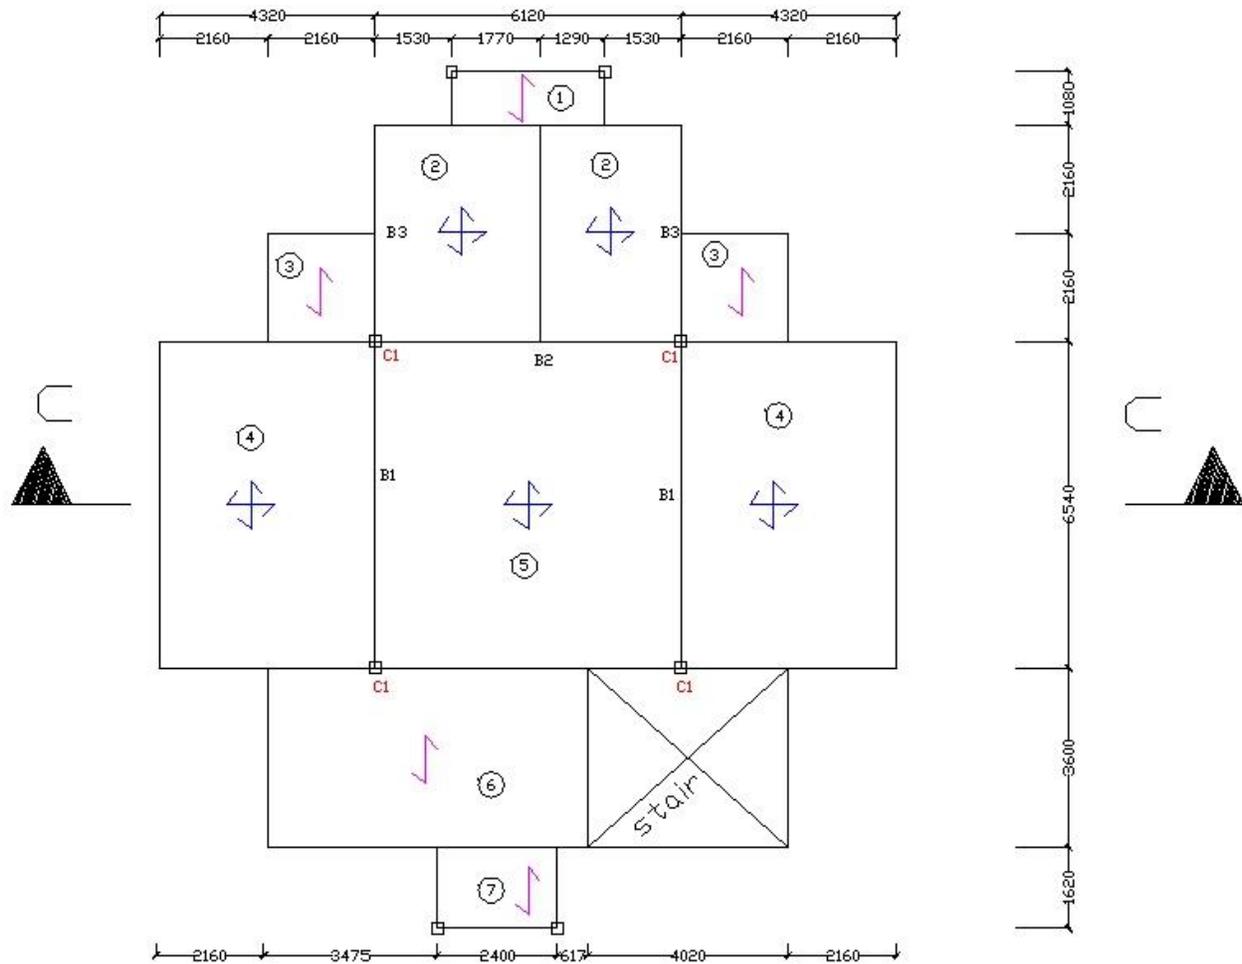
Fig. 7. General arrangement of the first floor plan of the building.

The general arrangement of the building as obtained during the site investigation is presented in fig. 7 showing the connections, arrangements and relative measurement of the structural skeletal frame work which include beams, columns and slab of the building under study.

Panel 5, beam B1, beam B3 and the partition walls were the most visibly failed portion of the building. The concrete works were observed to be sandy and seems not to bind properly due to inadequate quantity of cement and poor interpretation of concrete design mixture specification for the building. A section of the failed section of slab and beam of panel 5 showing the cracks, reinforcement arrangement and component thickness (depth) is presented in fig. 8. This crack is caused by inadequate slab depth and support for the slab spanning more than 6 meters and the supporting beams poorly reinforced. This occur due to poor technical supervision and quality control during the project execution.

The building ought to be designed by a specialist following prescribed guidelines or design codes as the building partial-collapse has caused economic loss to the client and unable to serve its economic life. A new structural design is expected to be conducted as one of the major task in the remedy program of partially-collapsed building according to the provisions of Codes of Practice BS 8110 [26,27], BS 6399 [28], Moseley *et al.*, [29] and Kong *et al.*, [30]. Cracking, chiseling and re-construction of the building from foundation, then working on panels 4, 5 and all troubled regions of the skeletal frame work. The lessons learnt from this set-up shows the need for experts to be engaged in construction activities from start till the finish of the project. Due to high patronage rate of non-professionals in carrying out engineering projects, engineering support and development is critically lacking while the need to engage them goes begging.

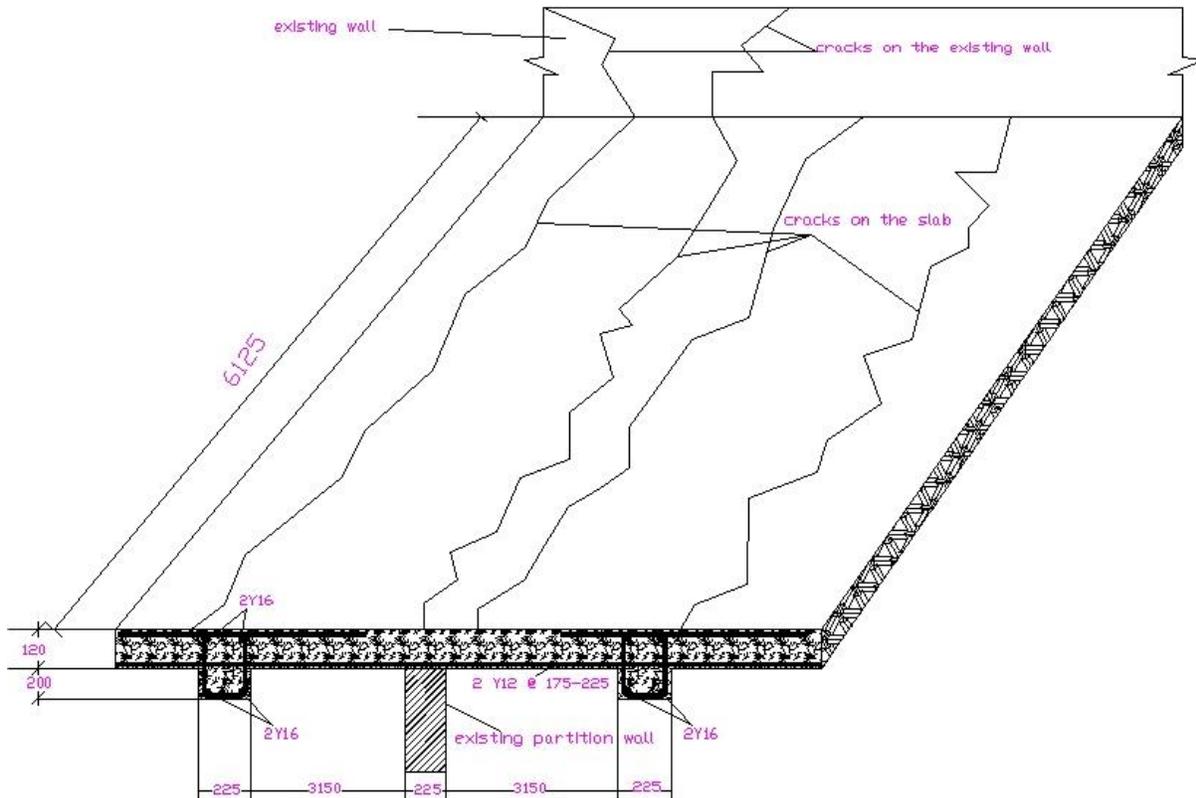
Fig. 8. Section through the Failed Portion.

The reinforcement placement for the slab section shown in figs. 8 and 9 was assessed by chiseling some section of the slab. This indicates a poor and crooked alignment of the steel bars which will cause poor distribution of load and cracks due to inadequate top reinforcement.
