Reliability Engineering and Resilience

Heat Flux Analysis due to Lightning Strike on Tubular Columns in TV and FM Towers

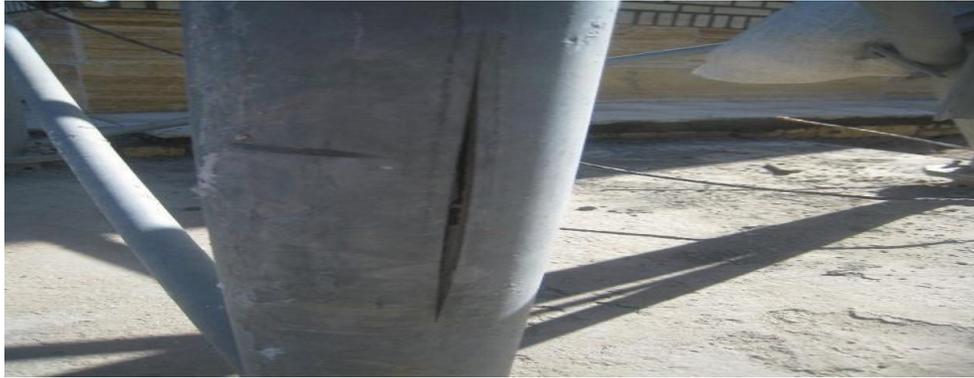
Fig. 5. Tear of the base of TV & FM tower due to lightning strike.

According to the objective observations one of the reasons that may be involved in the fracture of the base is the intense air expansion at the moment of the lightning discharge and the explosion of the tube pipe as a gas container, as it is likely that the stress caused by the dynamic load resulting from the expansion of the air It alone can break the pipe wall. Figure 5 shows the tear along the longitudinal axis of the base.

The rupture of the base body occurs in all cases from the inside outwards. This is a case of bursting hypothesis due to various lightning factors such as dynamic pressure due to gas expansion, strong electric current flow from the base body, high heat of electrical flux and magnetic flux in the base body. Sometimes, there are two or more factors that can cause these injuries.

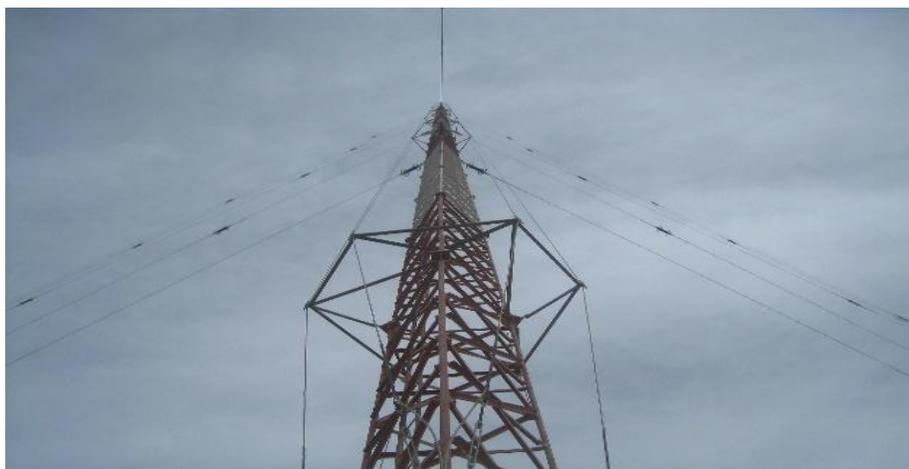
Fig. 8. Leading rope of AM radio aerial.

Surface degradation and corrosion observed in some structures are due to the same continuous currents that progress over time and eventually cause cracking. In the AM antenna, if the antenna is routed directly to the antenna, then the antenna system will not be able to send radio waves, and the RF waves are practically ground; therefore, an open grill system should be used so that only a lightning strike can be transmitted to Earth. This is also true in antenna harness cables (Figure 8). For this reason, at the end of this thunderbolt system, two spheres arrays have been built with a special and robust alloy to support the operation of lightning transmission without affecting the antenna's function. (Figure 9); in these spheres, it is clearly that when the lightning strikes, due to the arc intense electrical arc between the two metals, over time, many corrosion occurs, and as more surface is destroyed, corrosion also happens faster.

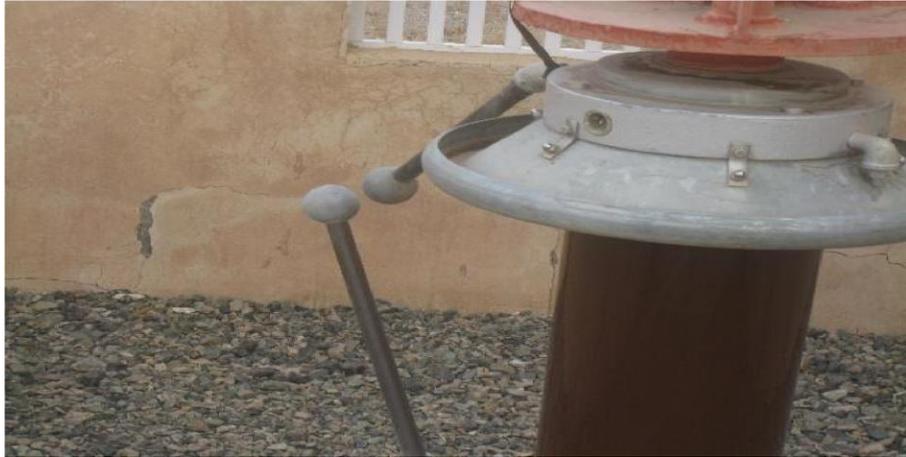
Fig. 9. Superficial demolition due to lightning strikes.
